SIO Shipyard Representative Bi-Weekly Progress Report		
Project: AGOR 28	Contract No.: N00014-12-C-0305	Shipyard: Dakota Creek Industries
Prepared by: Paul D. Bueren Scripps Institution of Oceanography (SIO) 297 Rosecrans St. San Diego, CA 98106	Date: 30 August, 2013	Program Officer: Robert (Tim) Schnoor Office of Naval Research 875 Randolph St ONR 321 Arlington, VA 22203-1995
Distribution Statement A: Approved for public release; distribution unlimited.		Report No. A002.039

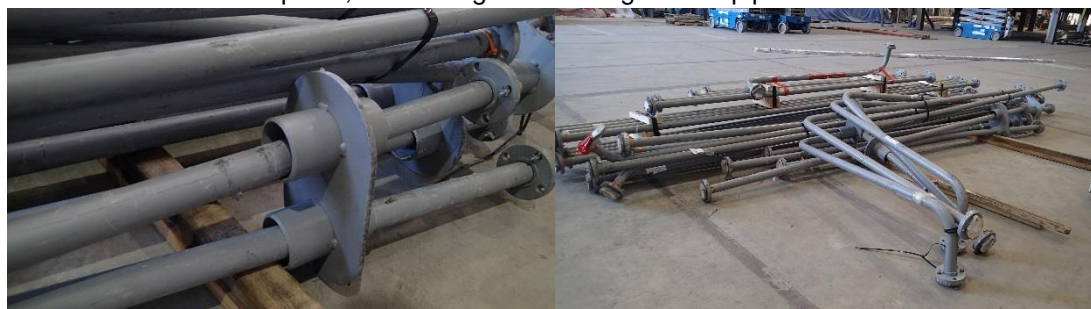
SIO agreed as it will eliminate the need for unlined stainless spool pieces between WT Bulkhead and Deck penetrations. The pipe has been delivered and is currently located in the Big House. In the pictures below, please note that the bulkhead and deck inserts are have been place on the piping prior to installing the Vanstone flanges. The penetrations will be sealed with approved sleeves after the flanges have been welded into place; eliminating heat damage to the pipe liner.

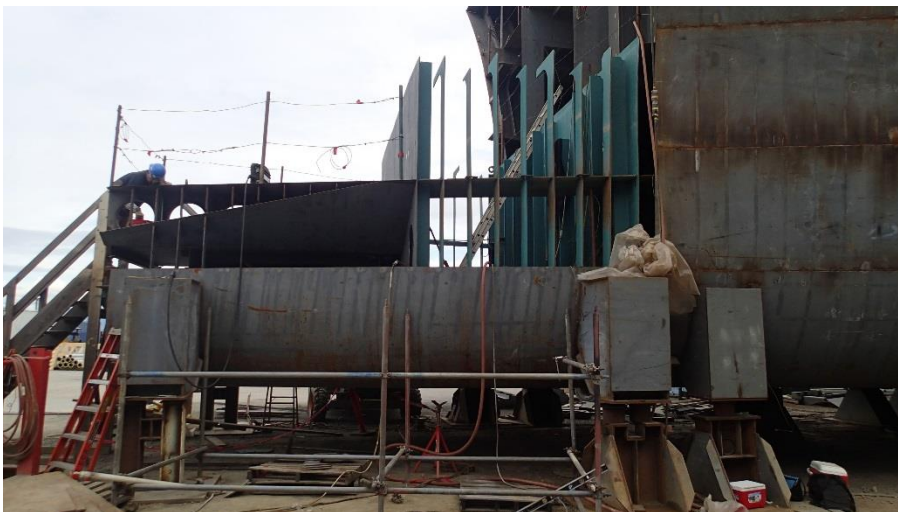
- Sally Ride Mod 1 Bow Thruster sub-assembly – The water side intake assembly has been set

and being fitted.
Ice belt and
frames fitted.

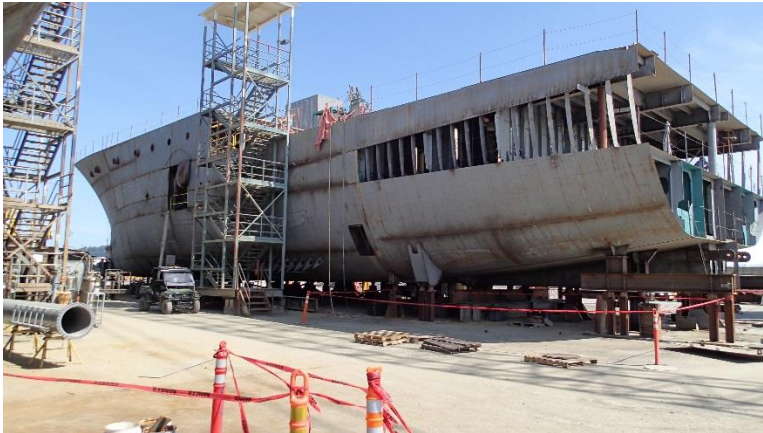
- Sally Ride Mod 5 – Side shell fitting in progress.

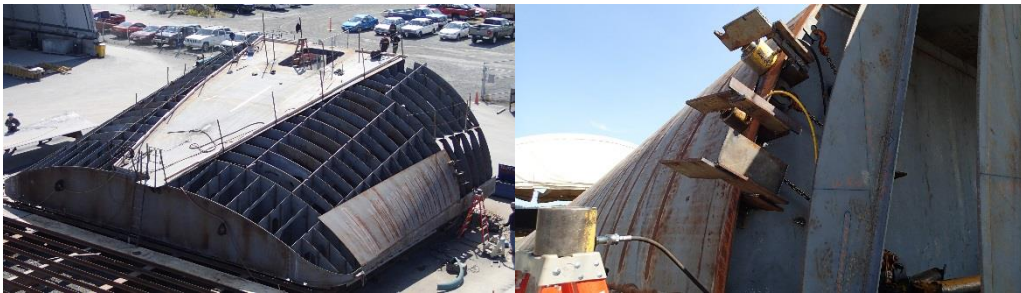
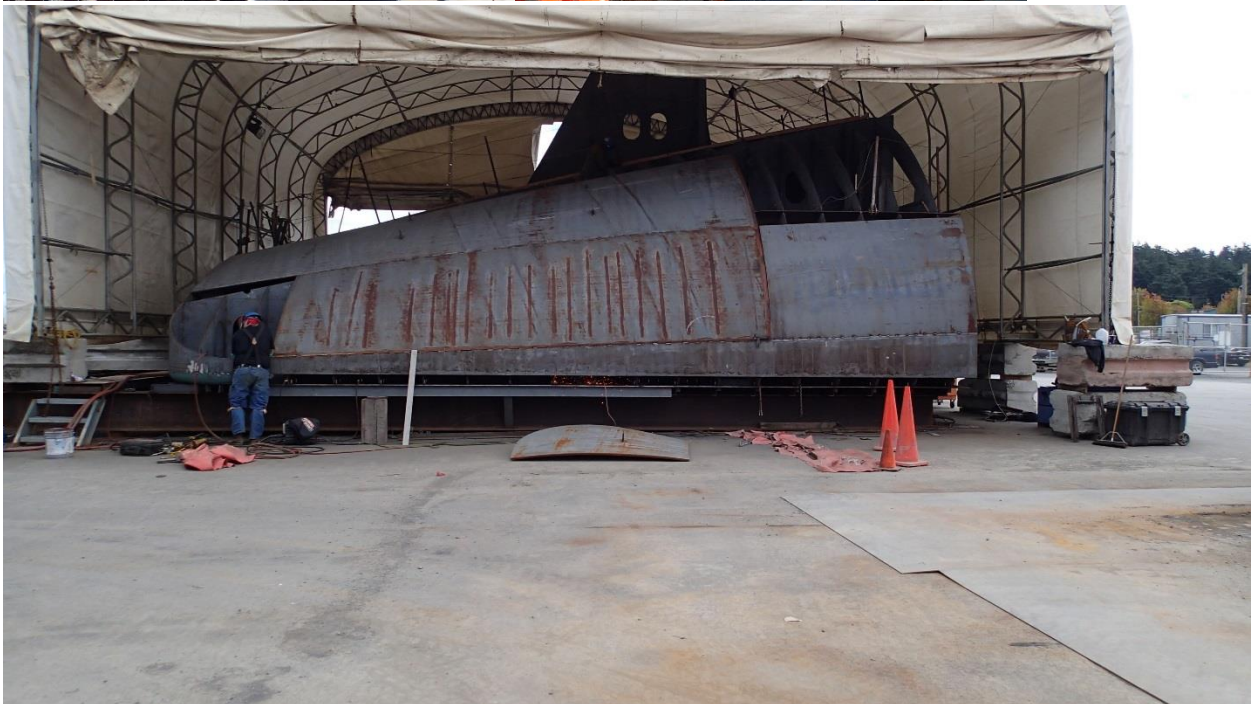
- Sally Ride Mod 6 Stern Section – A majority of the side and bottom shell plating has been fitted. The skeg and stern tunnel thruster foundation fabrication has begun.

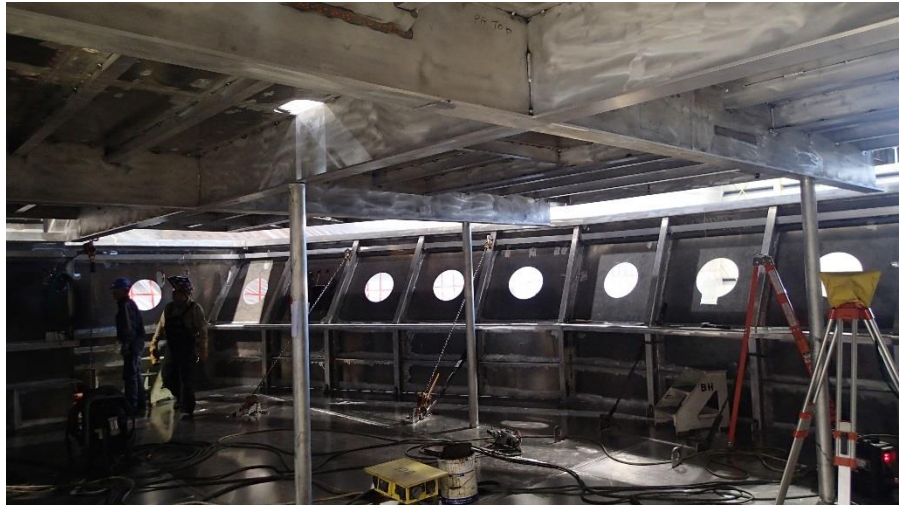
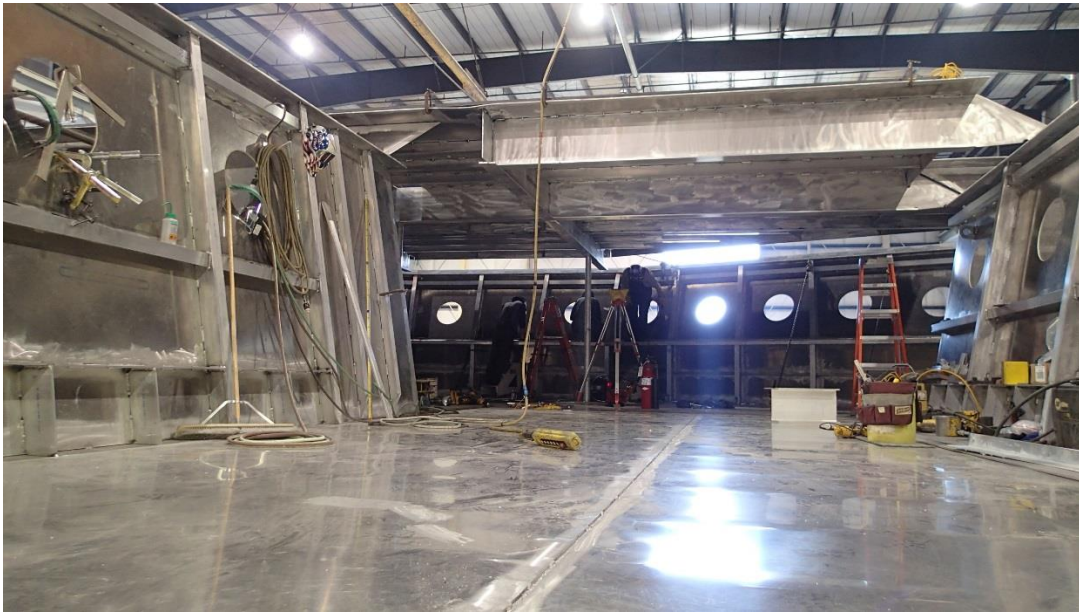
- Sally Ride Pilot House – Progress continues at a good pace on the Pilot House. All bulkheads are up and the forward overhead has been fitted. Lessons learned from Neil Armstrong are being put to good use.

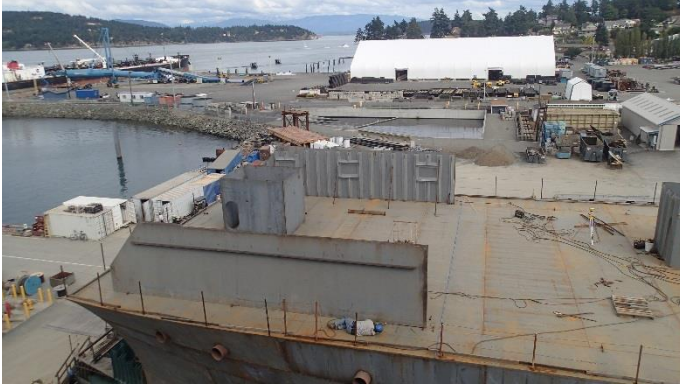
- Sally Ride Foc's'le House – Two exterior bulkheads have been landed with more to come. Most if not all of the bulkheads and decks are fabricated and ready for installation.
